MALVERN BOROUGH

Date: January 30, 2023

Reference: PROPOSED BIKE TRACK

File: 74721

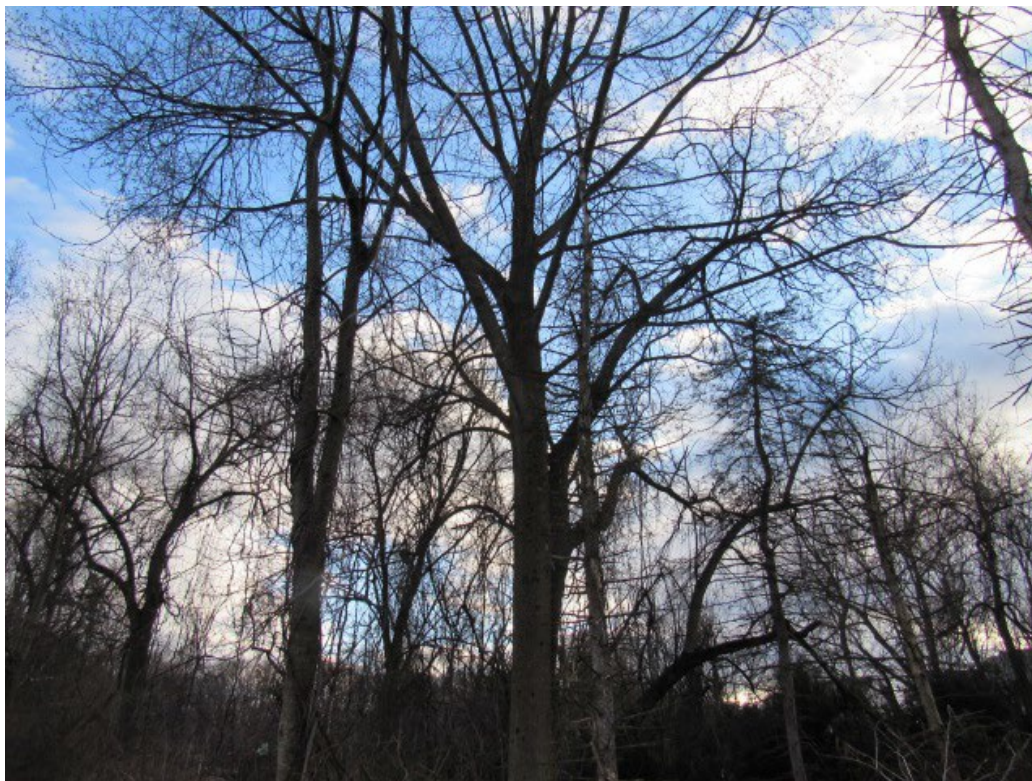
Photo 1, Mature Tulip Poplar rated in fair condition.

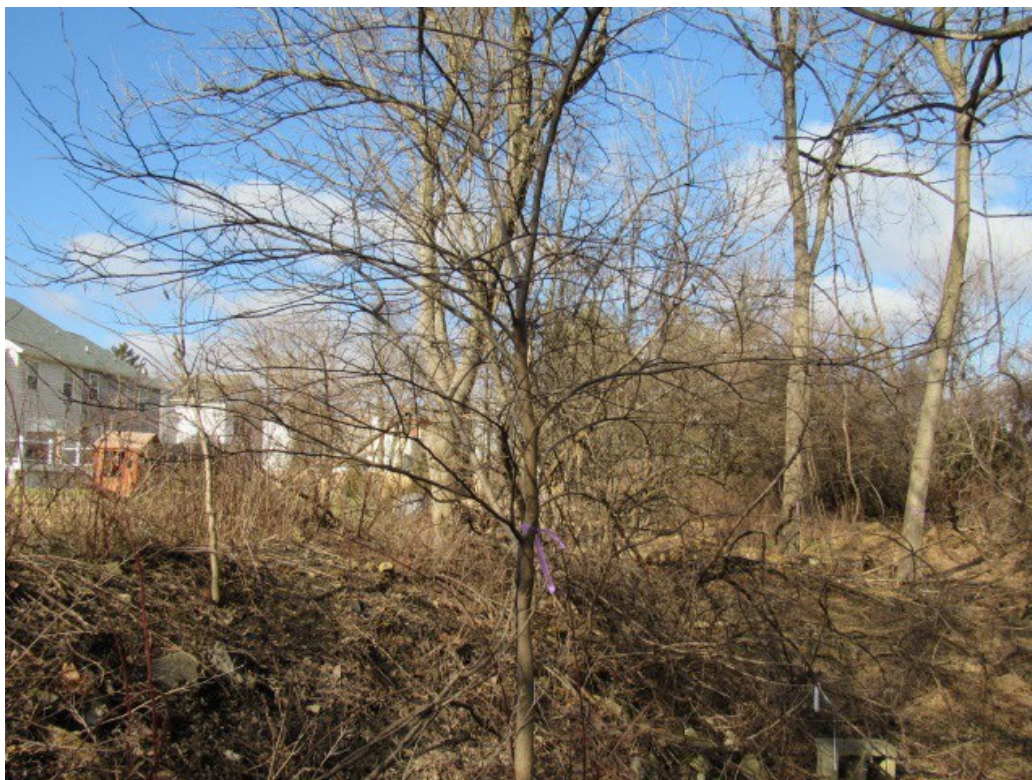
Photo 2, Young Eastern Redbud rated in fair condition.

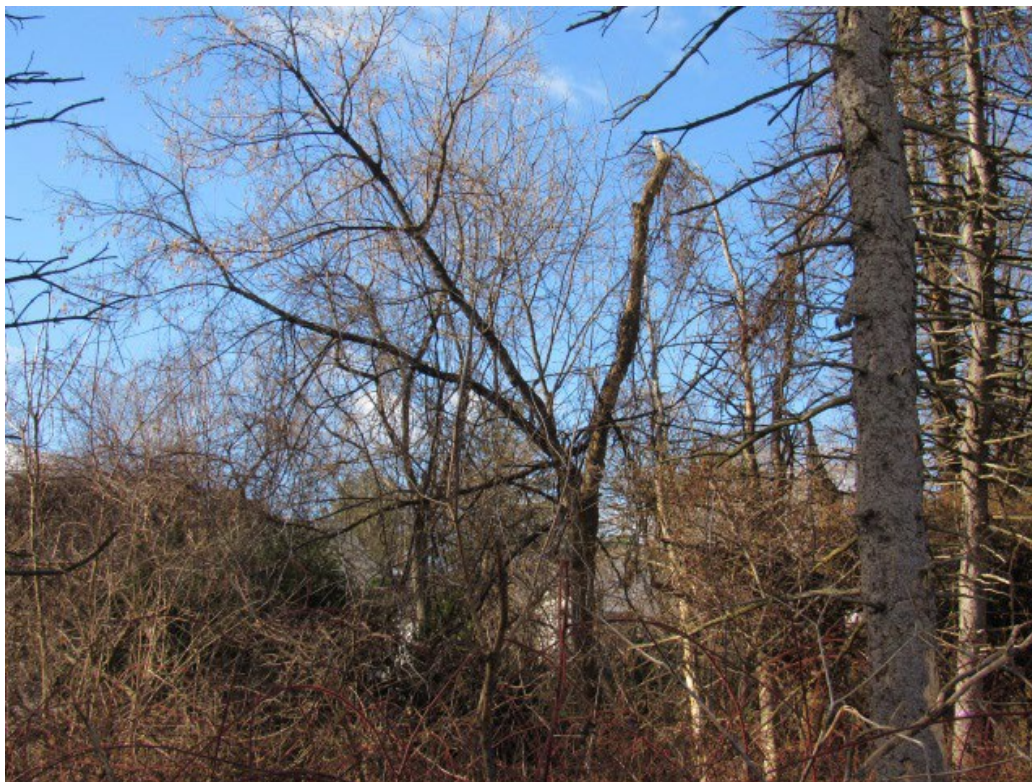
Photo 3, Boxelder with top missing, rated high risk.

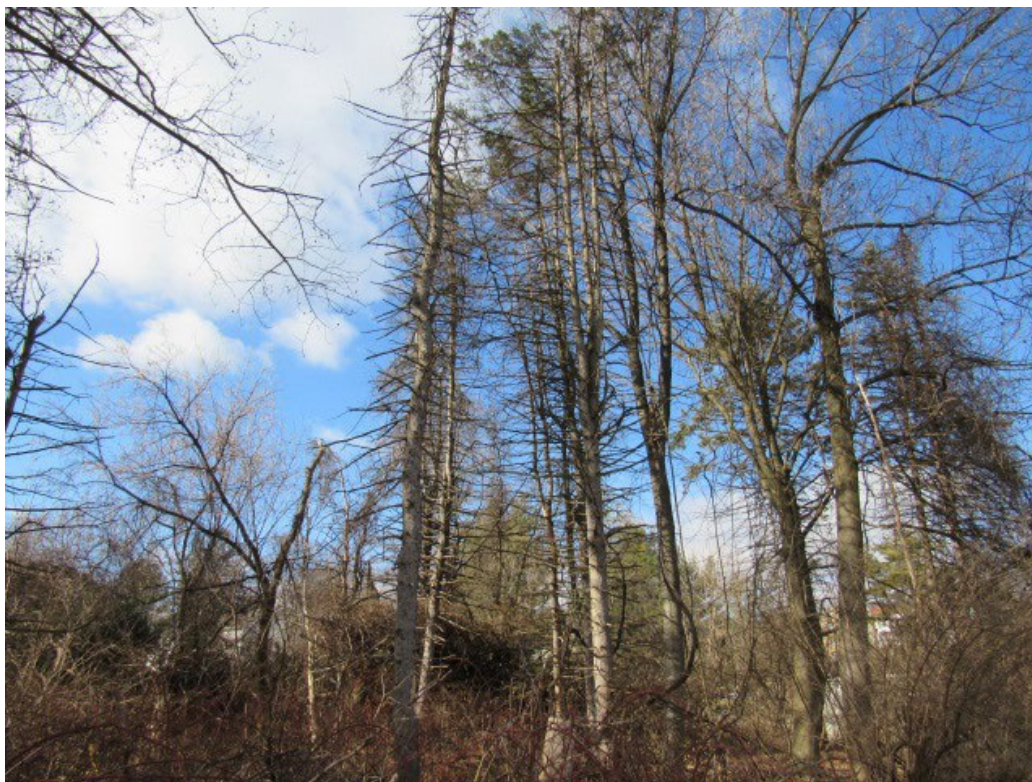
Photo 4, Dead, declining and decayed Blue Spruce, rated high risk.

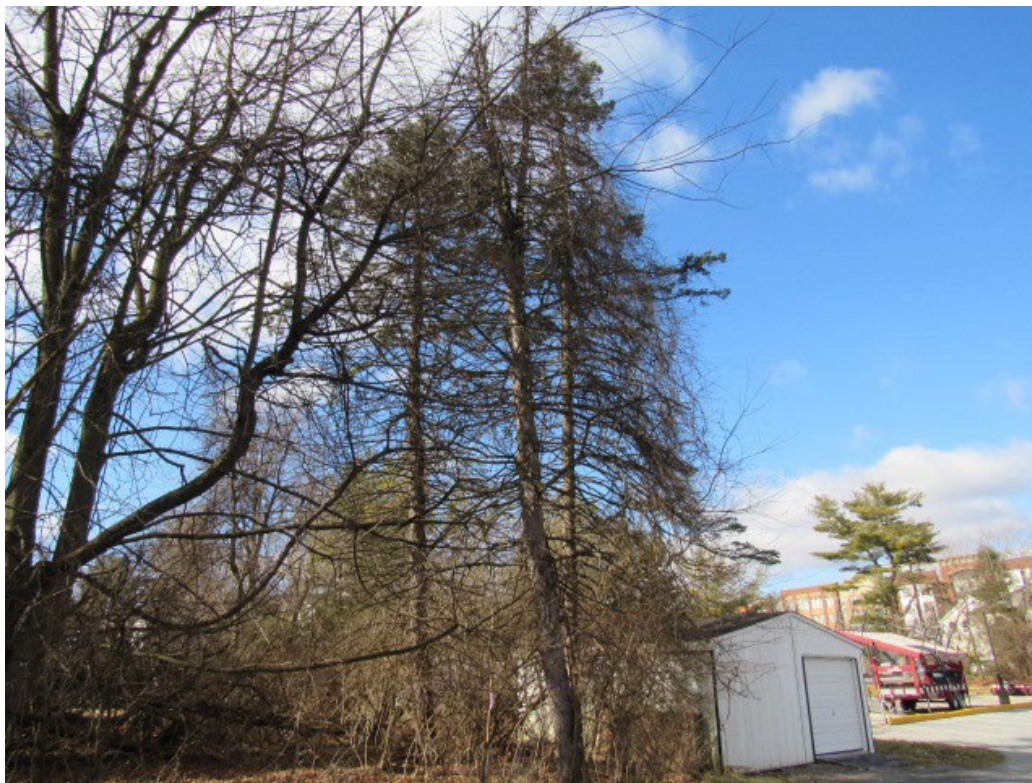
Photo 5, Declining Eastern White Pine.

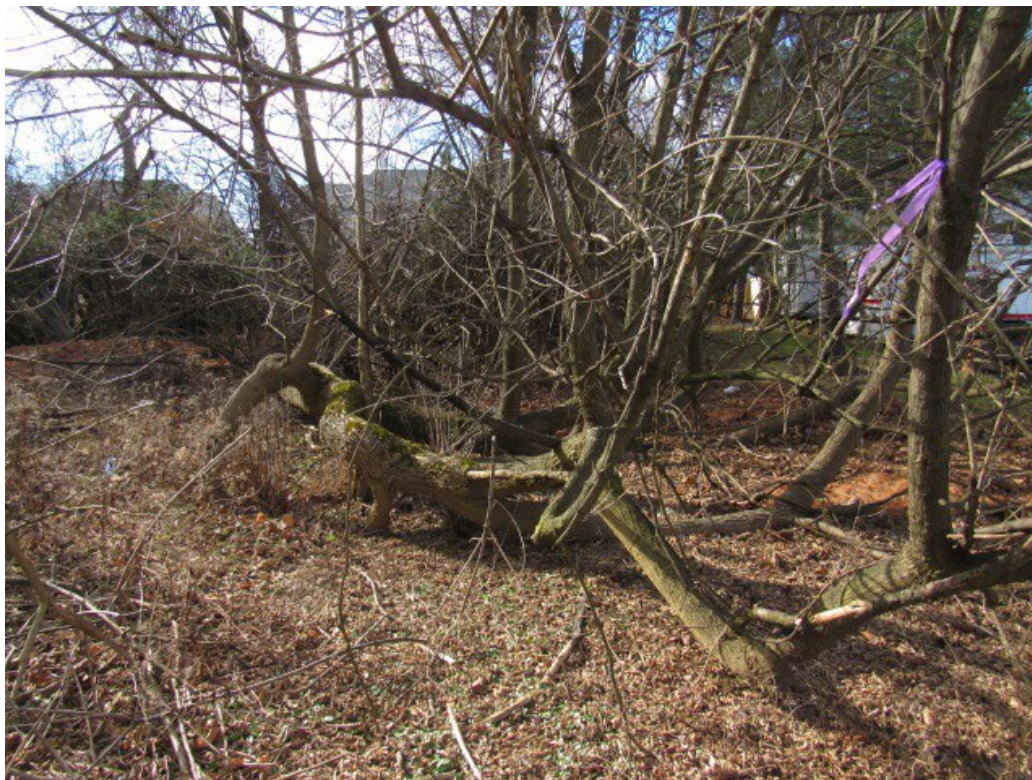
Photo 6, Wild Cherry uprooted and re-rooted.

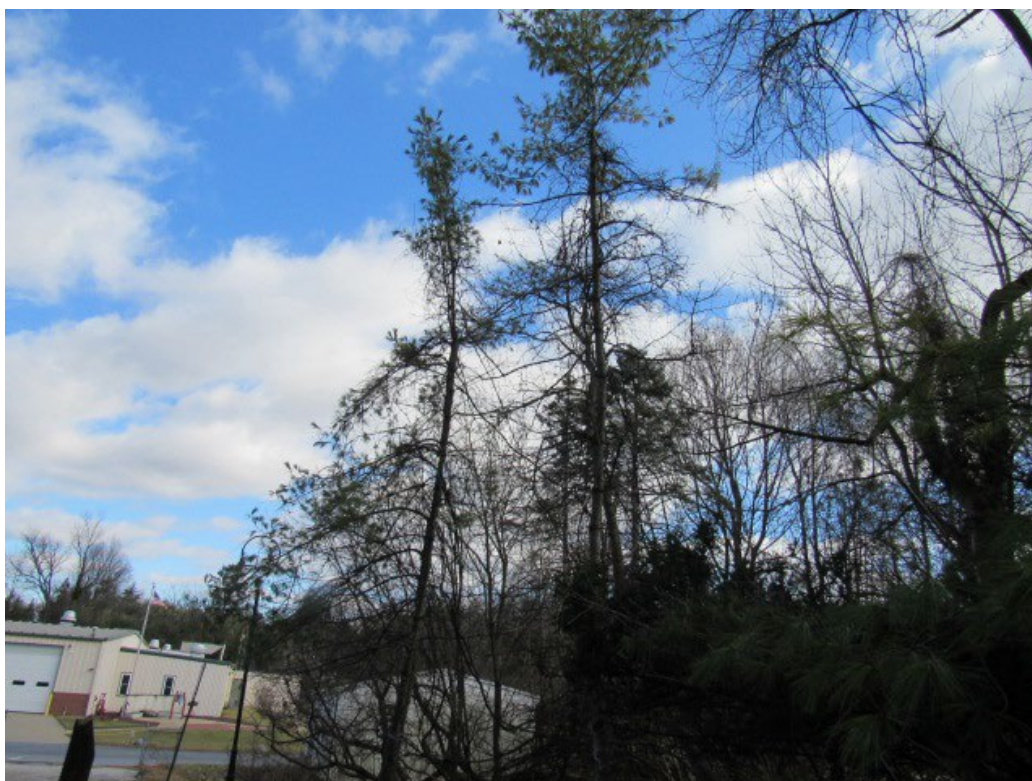
Photo 7, Declining Eastern White Pine.

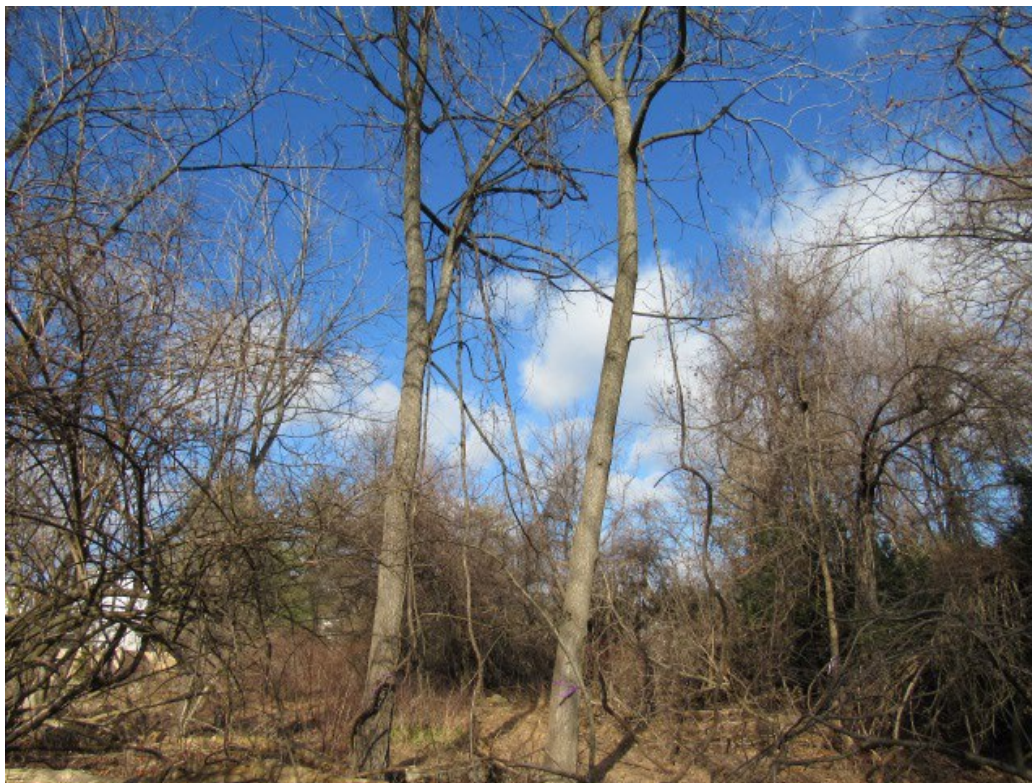
Photo 8, Mature Ash infested with Emerald Ash Borers, rated high risk.

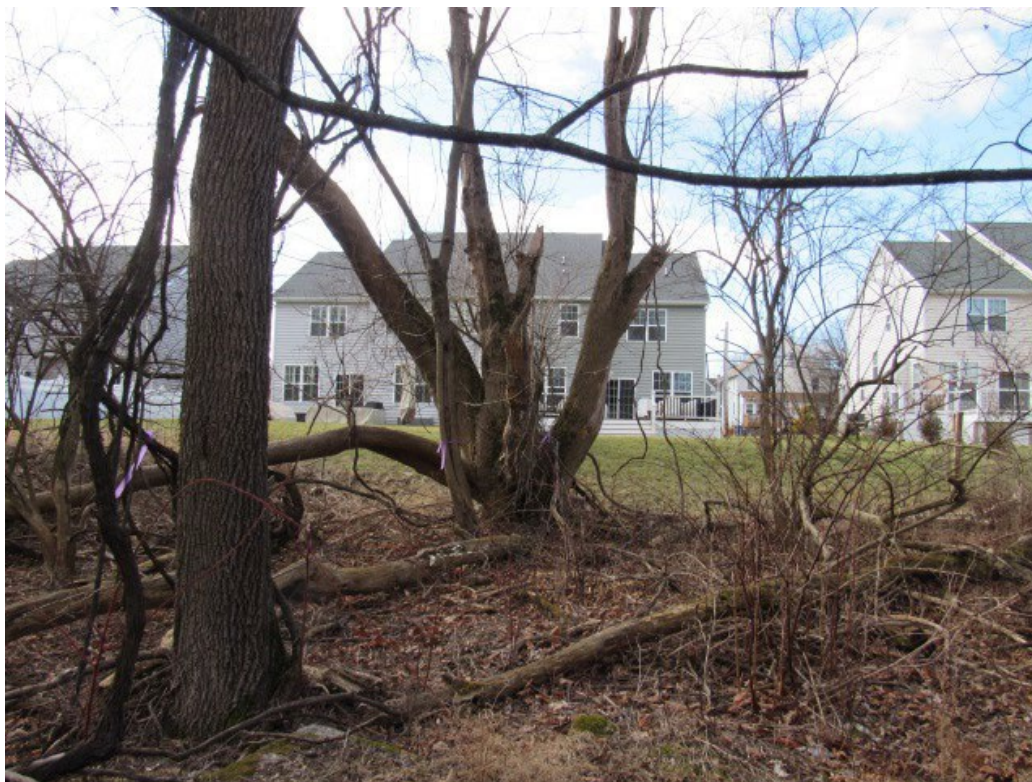
Photo 9, Large, declining Boxelder, rated high risk.

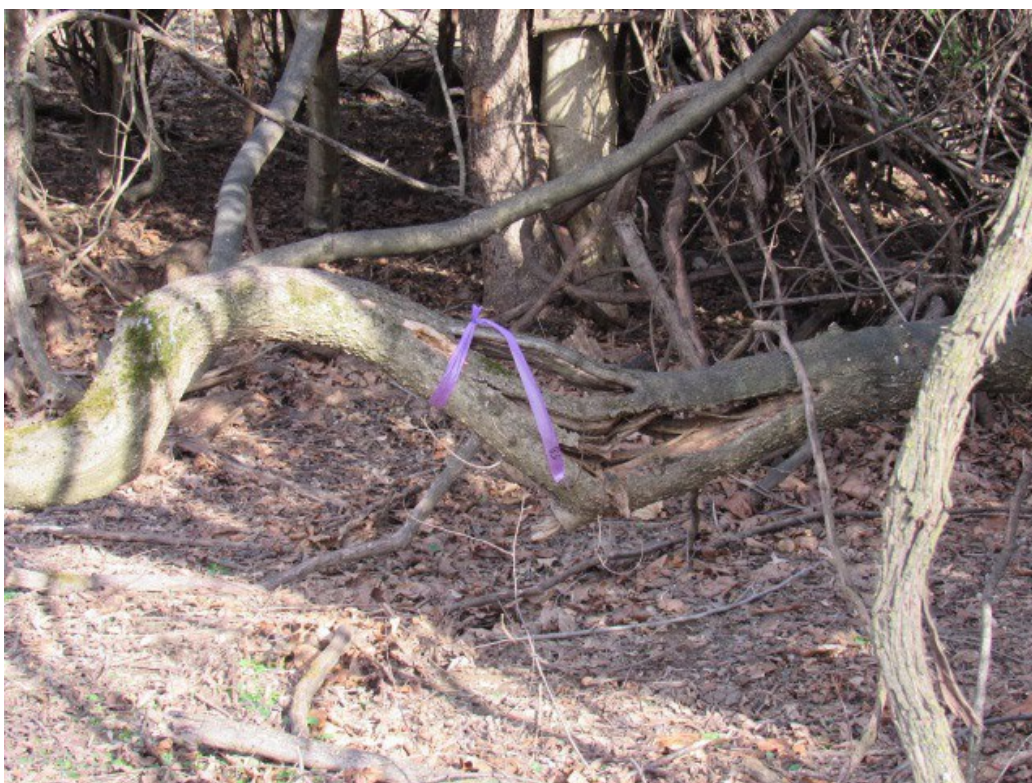
Photo 10, Wild Cherry split and close to ground.

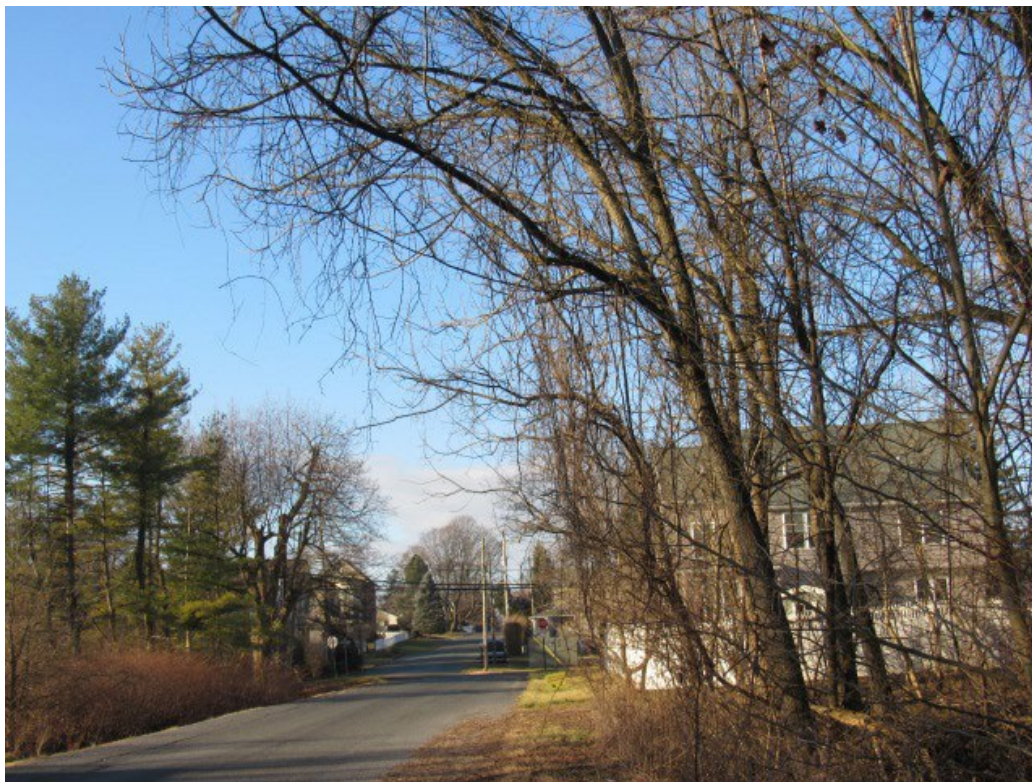
Photo 11, Leaning Wild Cherry over-hanging street.

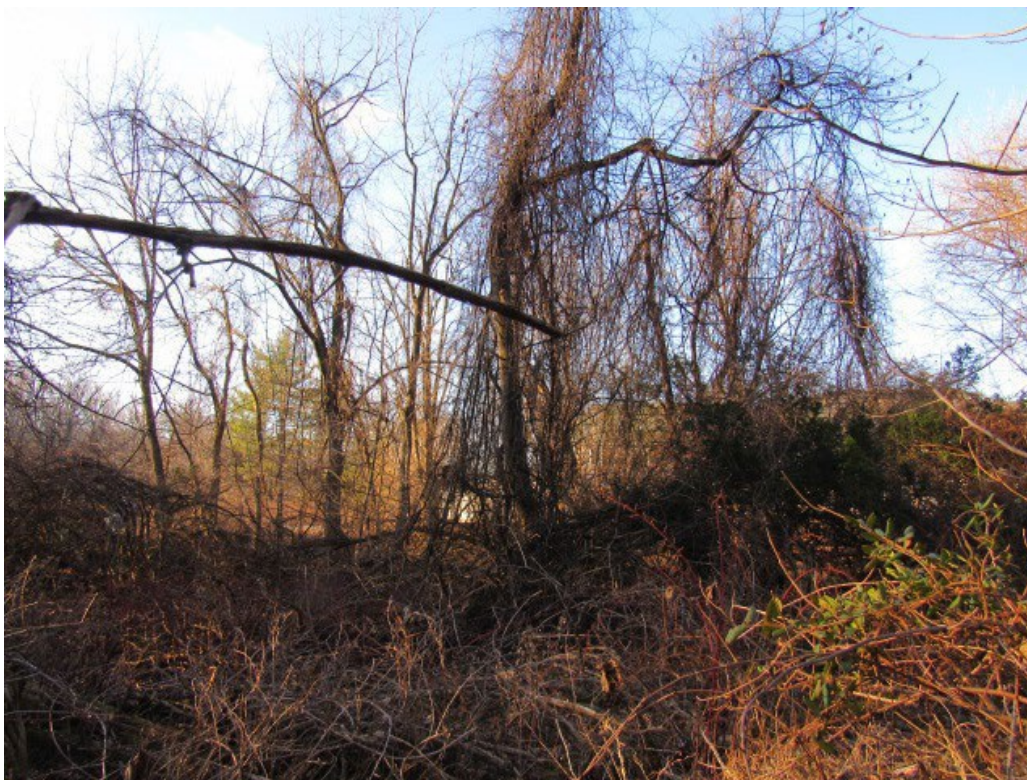
Photo 12, deformed Wild Cherry with sweep caused by invasive vines.

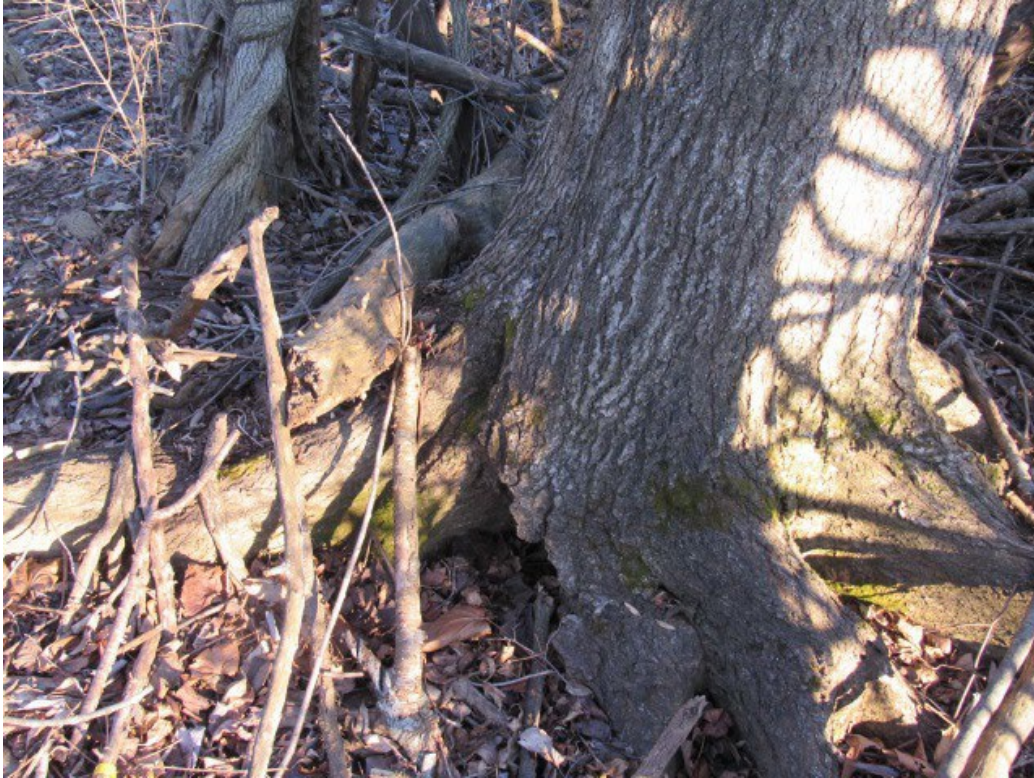
Photo 13, Base of mature Elm, Tree was rated fair with low risk.

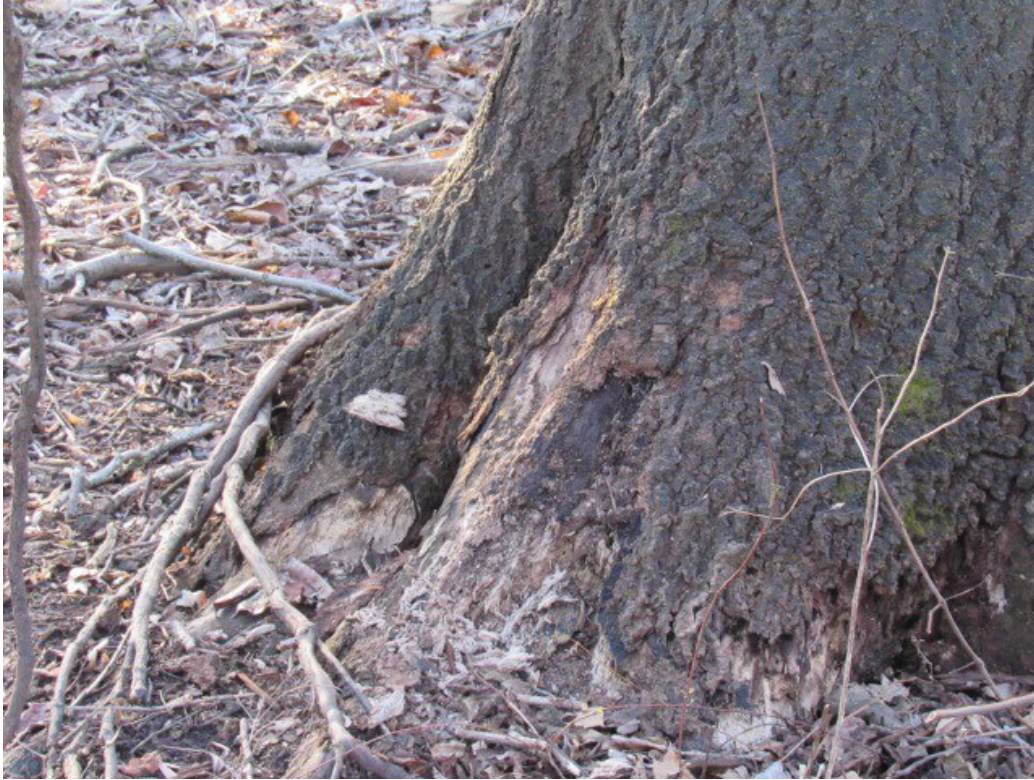
Photo 14, Decayed base of severely declining 32-inch diameter Paulownia.

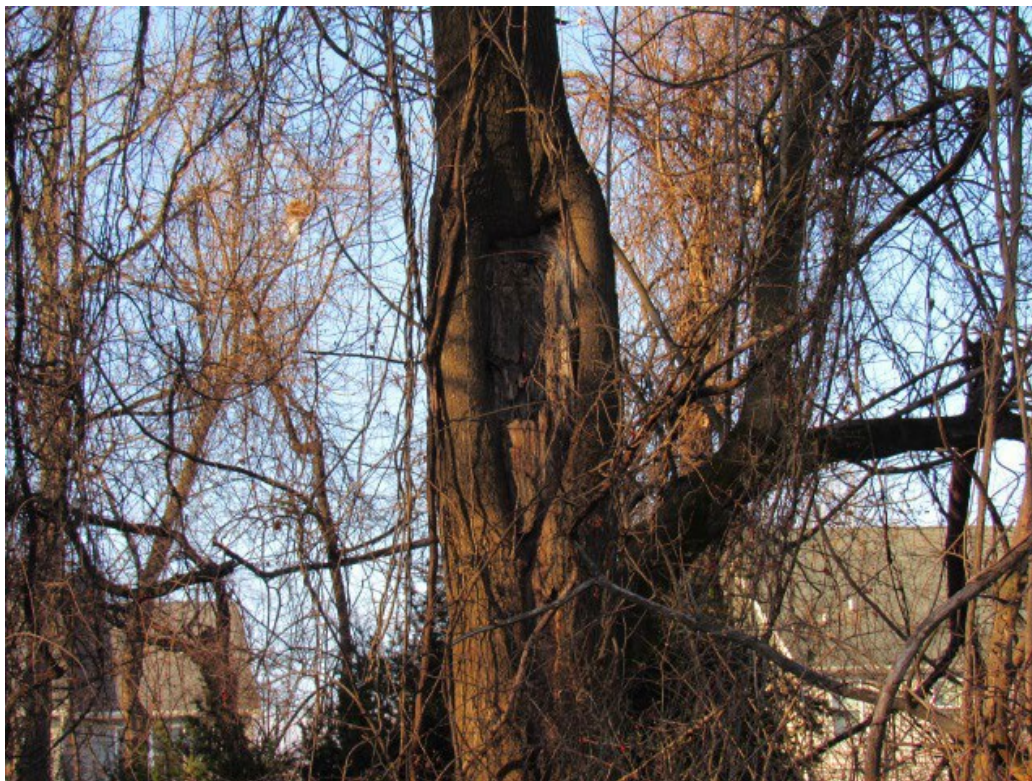
Photo 15, Very large cavity in main stem of mature Tulip Poplar, rated as high risk.

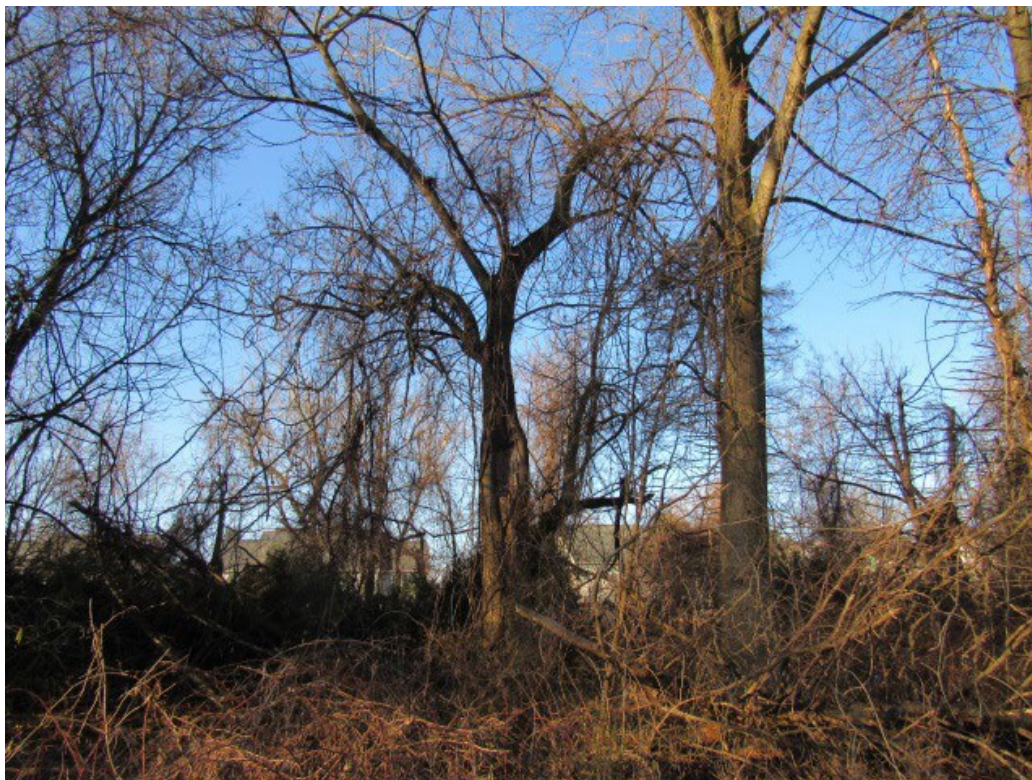
Photo 16, Mature Tulip Poplar with cavity, also showing severe lean.

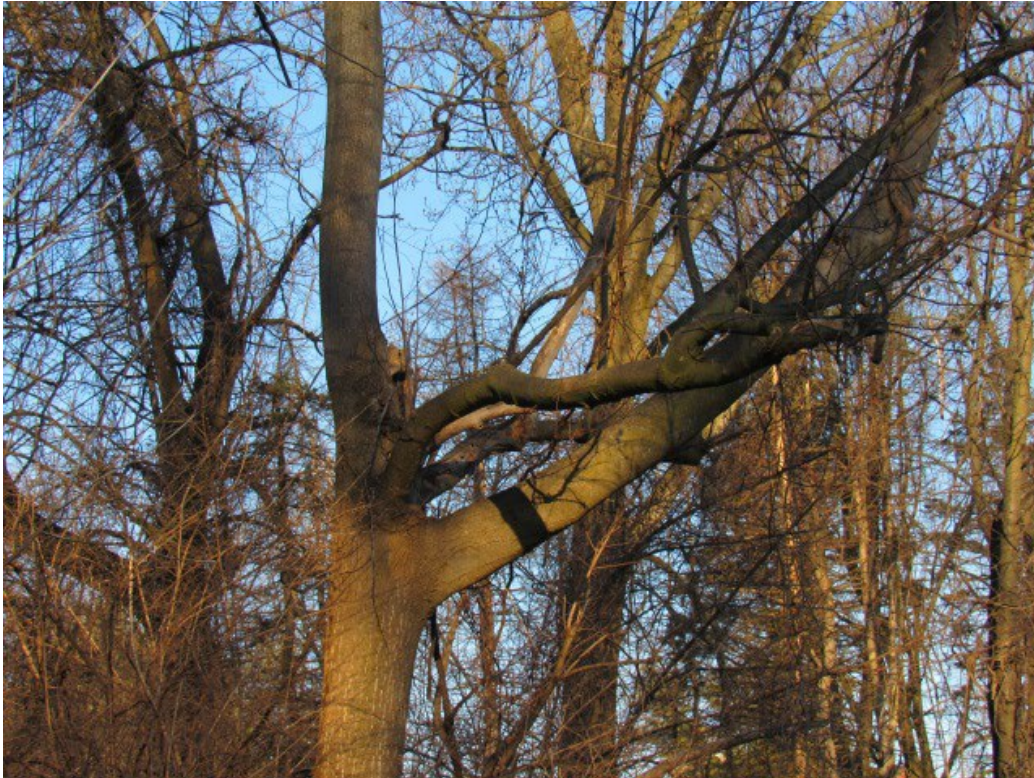
Photo 17, Mature Tulip poplar with large cavity located in upper stem, rated high risk.

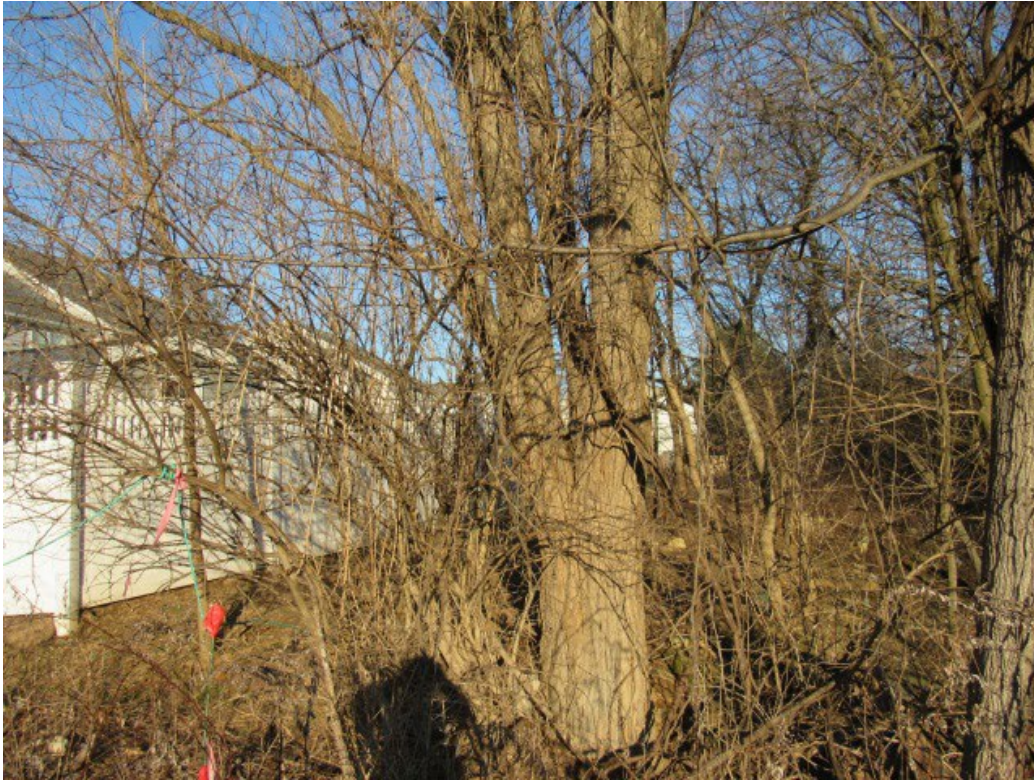
Photo 18, Mature Black Locust with bifurcated stem arrangement, rated high risk.

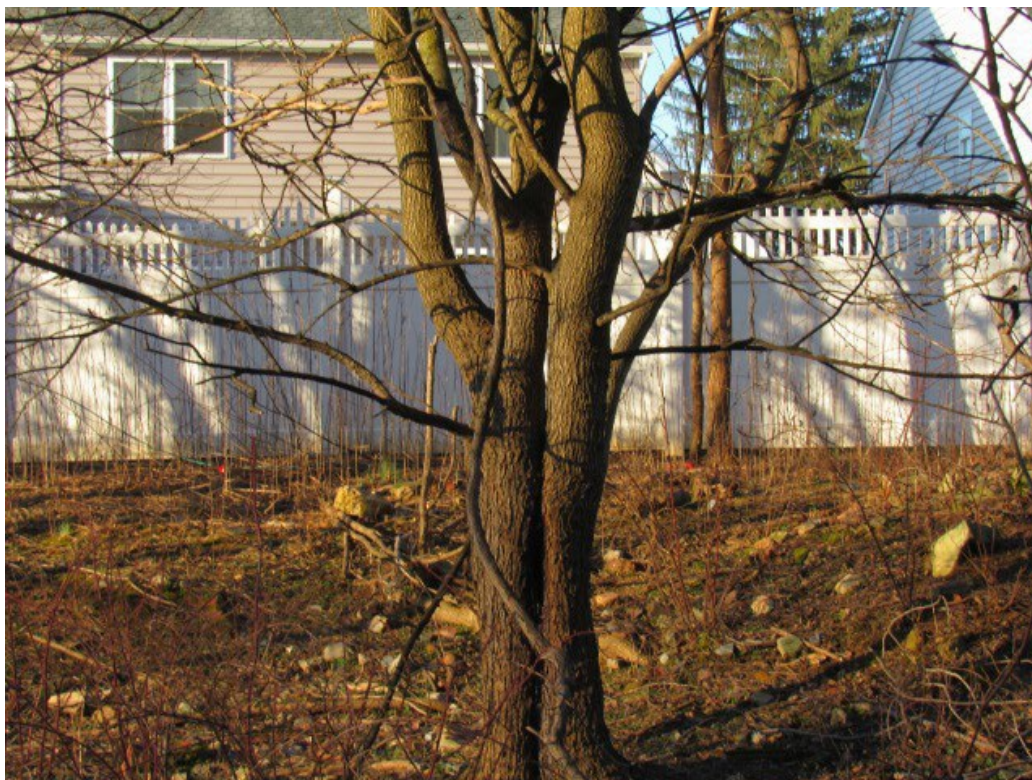
Photo 19, Mulberry with bifurcated stem, rated high risk.

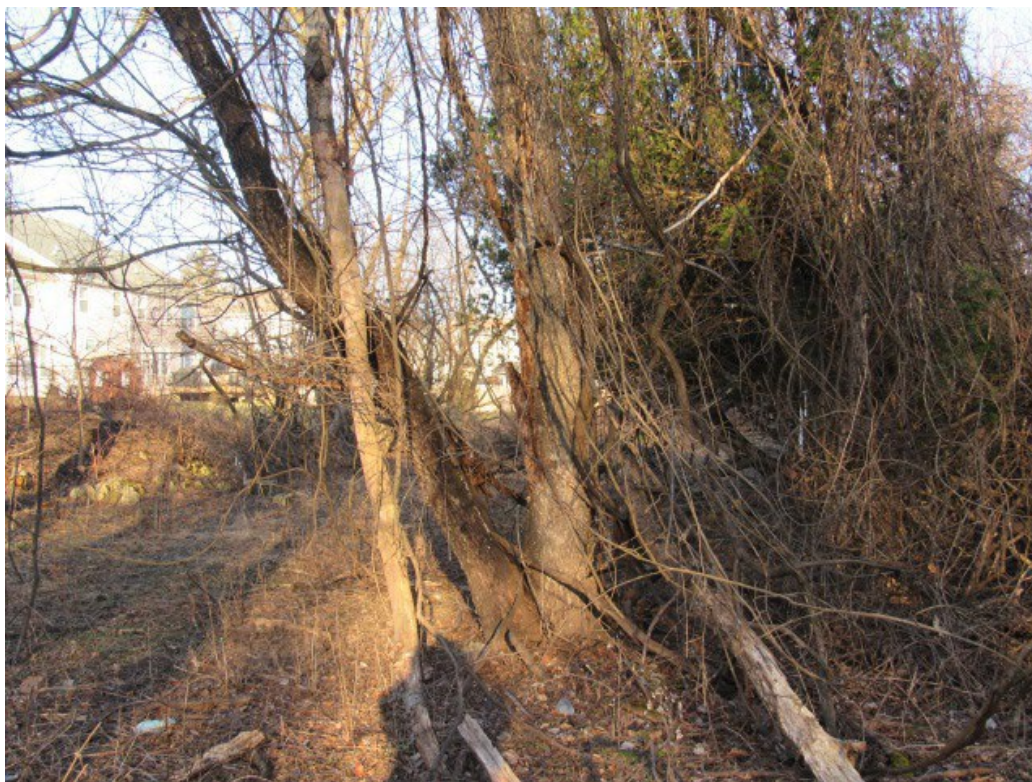
Photo 20, Wild Cherry with bifurcated stem, rated high risk.
